MSDF destroyer runs over fishing boat; 2 missing

Crew members tell the Defense Ministry that they saw the fishing vessel too late.

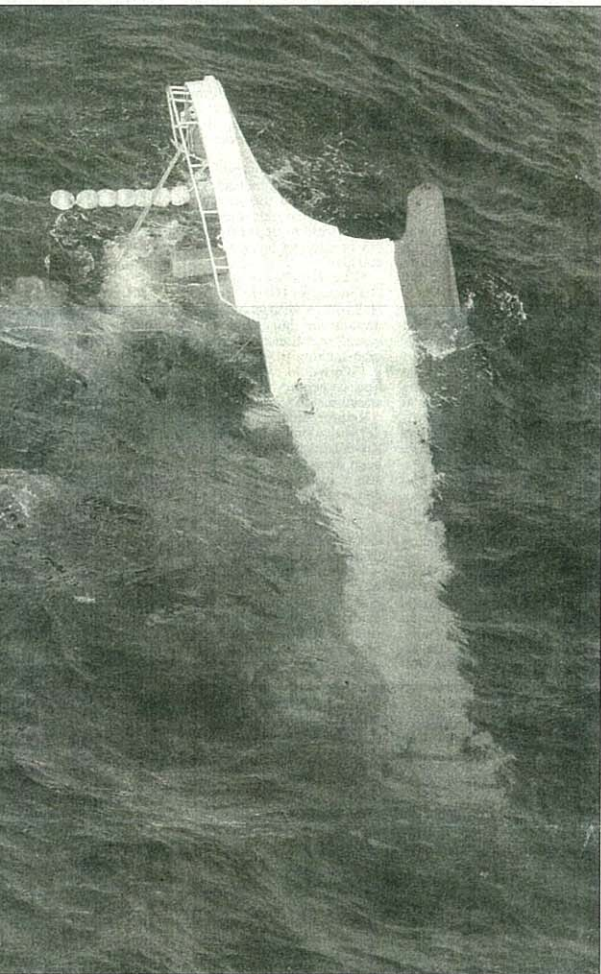
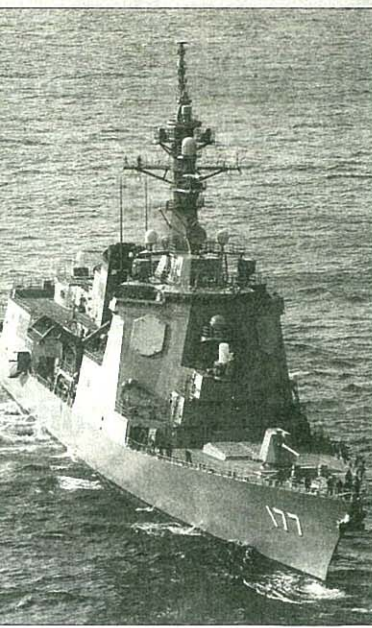
The fishing vessel Seitoku Maru was split in half. Atago crew members searched the area for survivors but were unable to find the two fishermen.

Above: The bow of the Seitoku Maru floats off Nojimazaki, Chiba Prefecture, on Tuesday after the fishing boat was split in two in a collision with the Maritime Self-Defense Force's Atago destroyer. Left, Right: The accident left scrapes on the bow of the Aegis-equipped destroyer.

The two vessels appear to have collided almost at right angles to each other, severely damaging the fishing boat's port side, according to Japan Coast Guard officials.
